Analysis of MSE Retaining Wall

Gale-Tec Engineering, Inc.

A section of retaining wall H on Trunk Highway 41 (TH41) south of the junction with TH212 in Chaska, Minnesota, "pushed out" following significant rainfall during construction. The rainfall event occurred prior to the pavement placement with the fill material exposed.

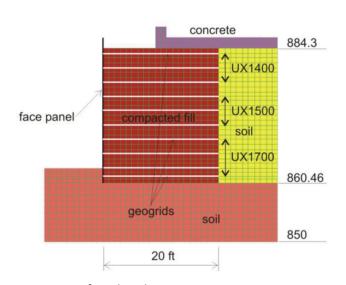
The movement (horizontal displacement) of the wall that occurred after the rainfall event was permanent and visible.

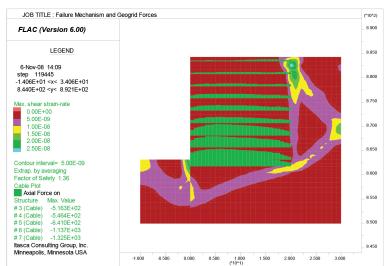
Itasca determined that the observed wall movement likely resulted from the combination of two effects:

- · rise of the water table in the fill; and
- seepage of water from the top, combined with migration of the fill material.

We determined that sagging of the geogrids, inferred from the settlements on the surface, have a relatively small effect on the factor of safety. The observed deformation (rotation) of the wall was predicted to have no effect on long-term stability and the wall factor of safety based on present conditions. Future rain events could result in further loss of fines through the wall and thus a buttress was added to the lower half of the wall.

Shear strains (failure mechanism) and geogrid forces.
