NON-LINEAR STRANING OF FOUNDATION SOILS IN THE PROGRESSIVE FAILURE OF THE MOUNT POLLEY TSF EMBANKMENT

E. Zabolotnii, R.N. Morgenstern and G.W. Wilson

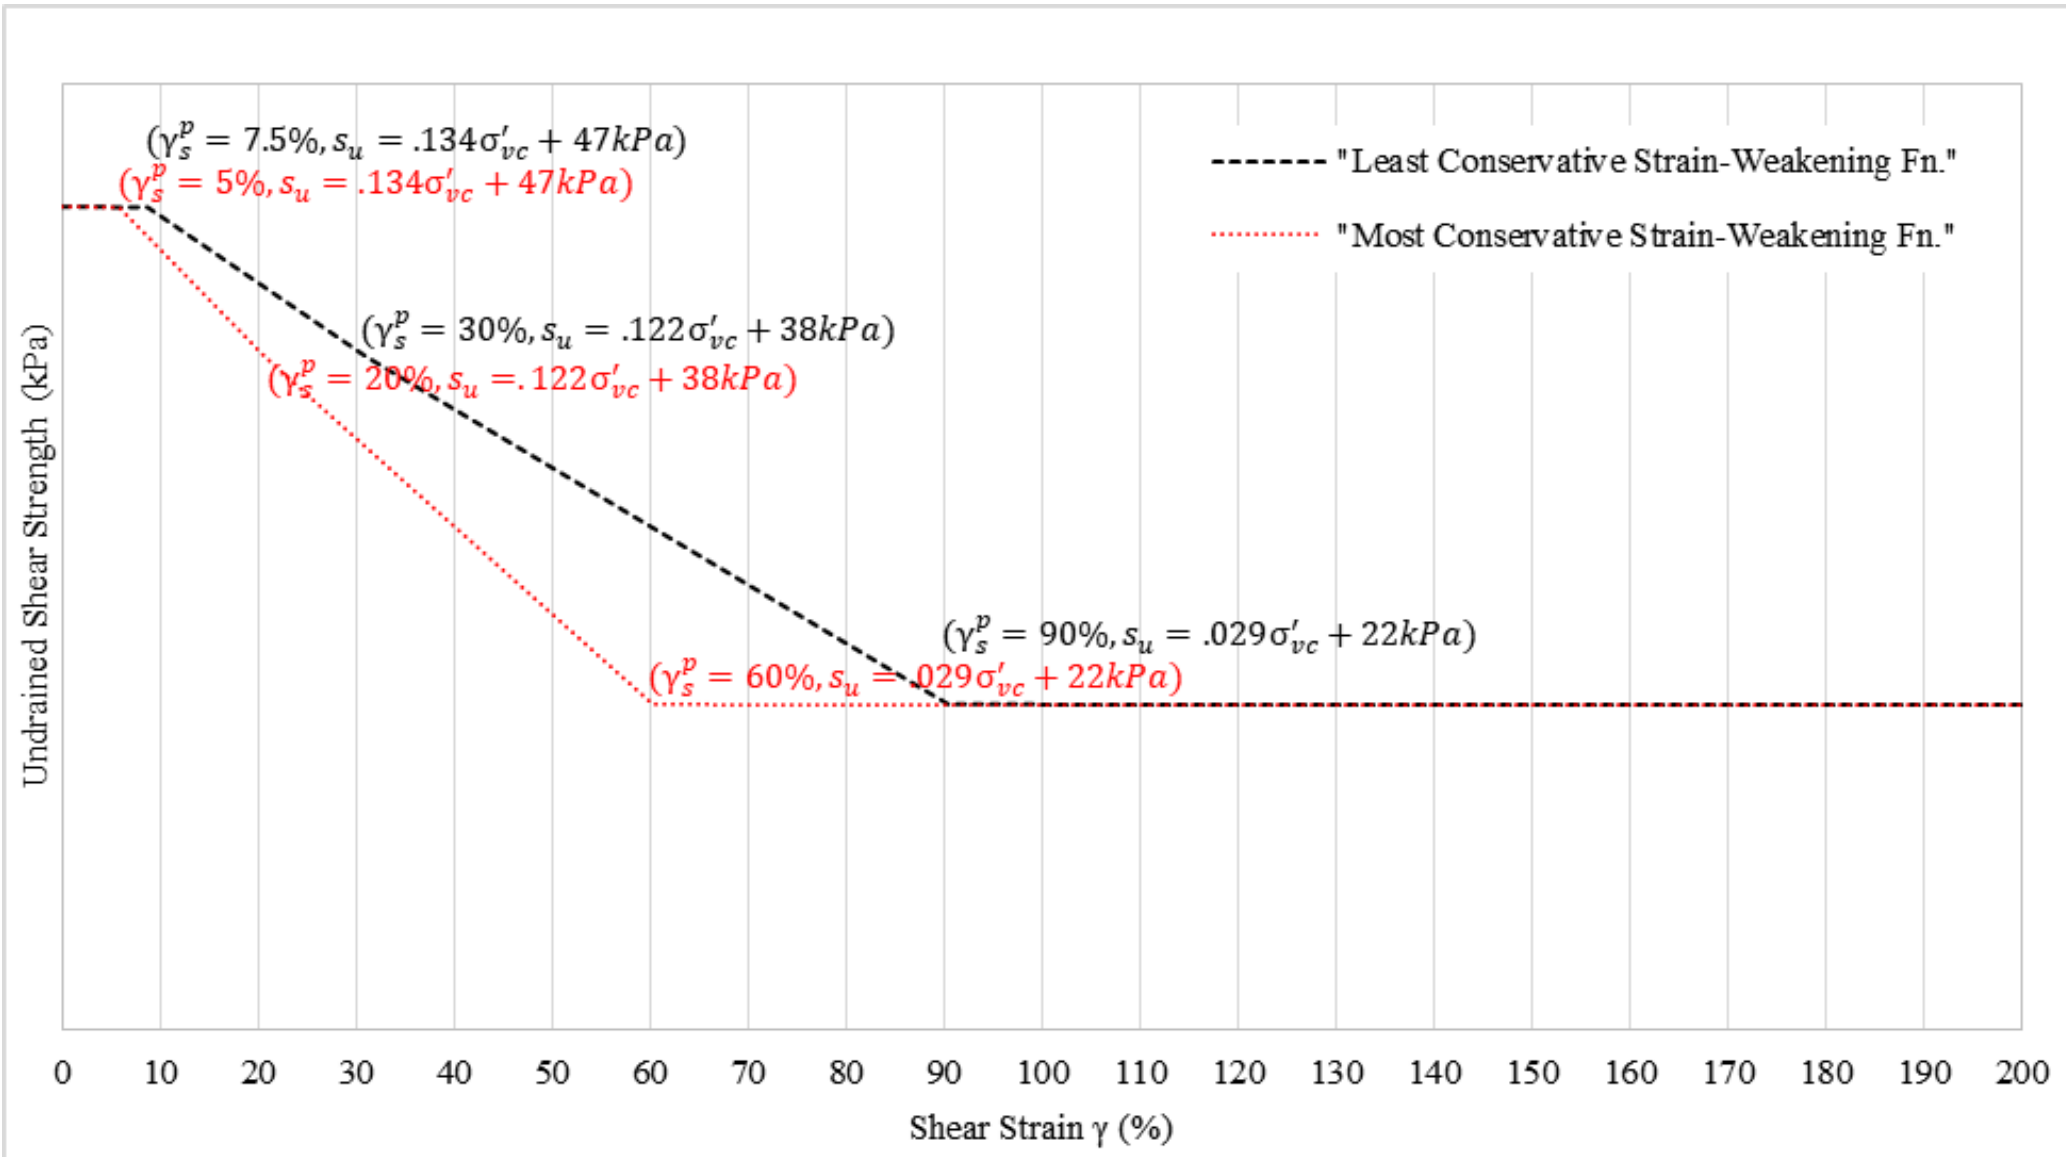
DSS-derived strain-weakening curves:

- From lab tests: >60% shear strains = full weakening
- In a 2m layer, this suggests shear displacements of 1.2 m before collapse if straining is uniform

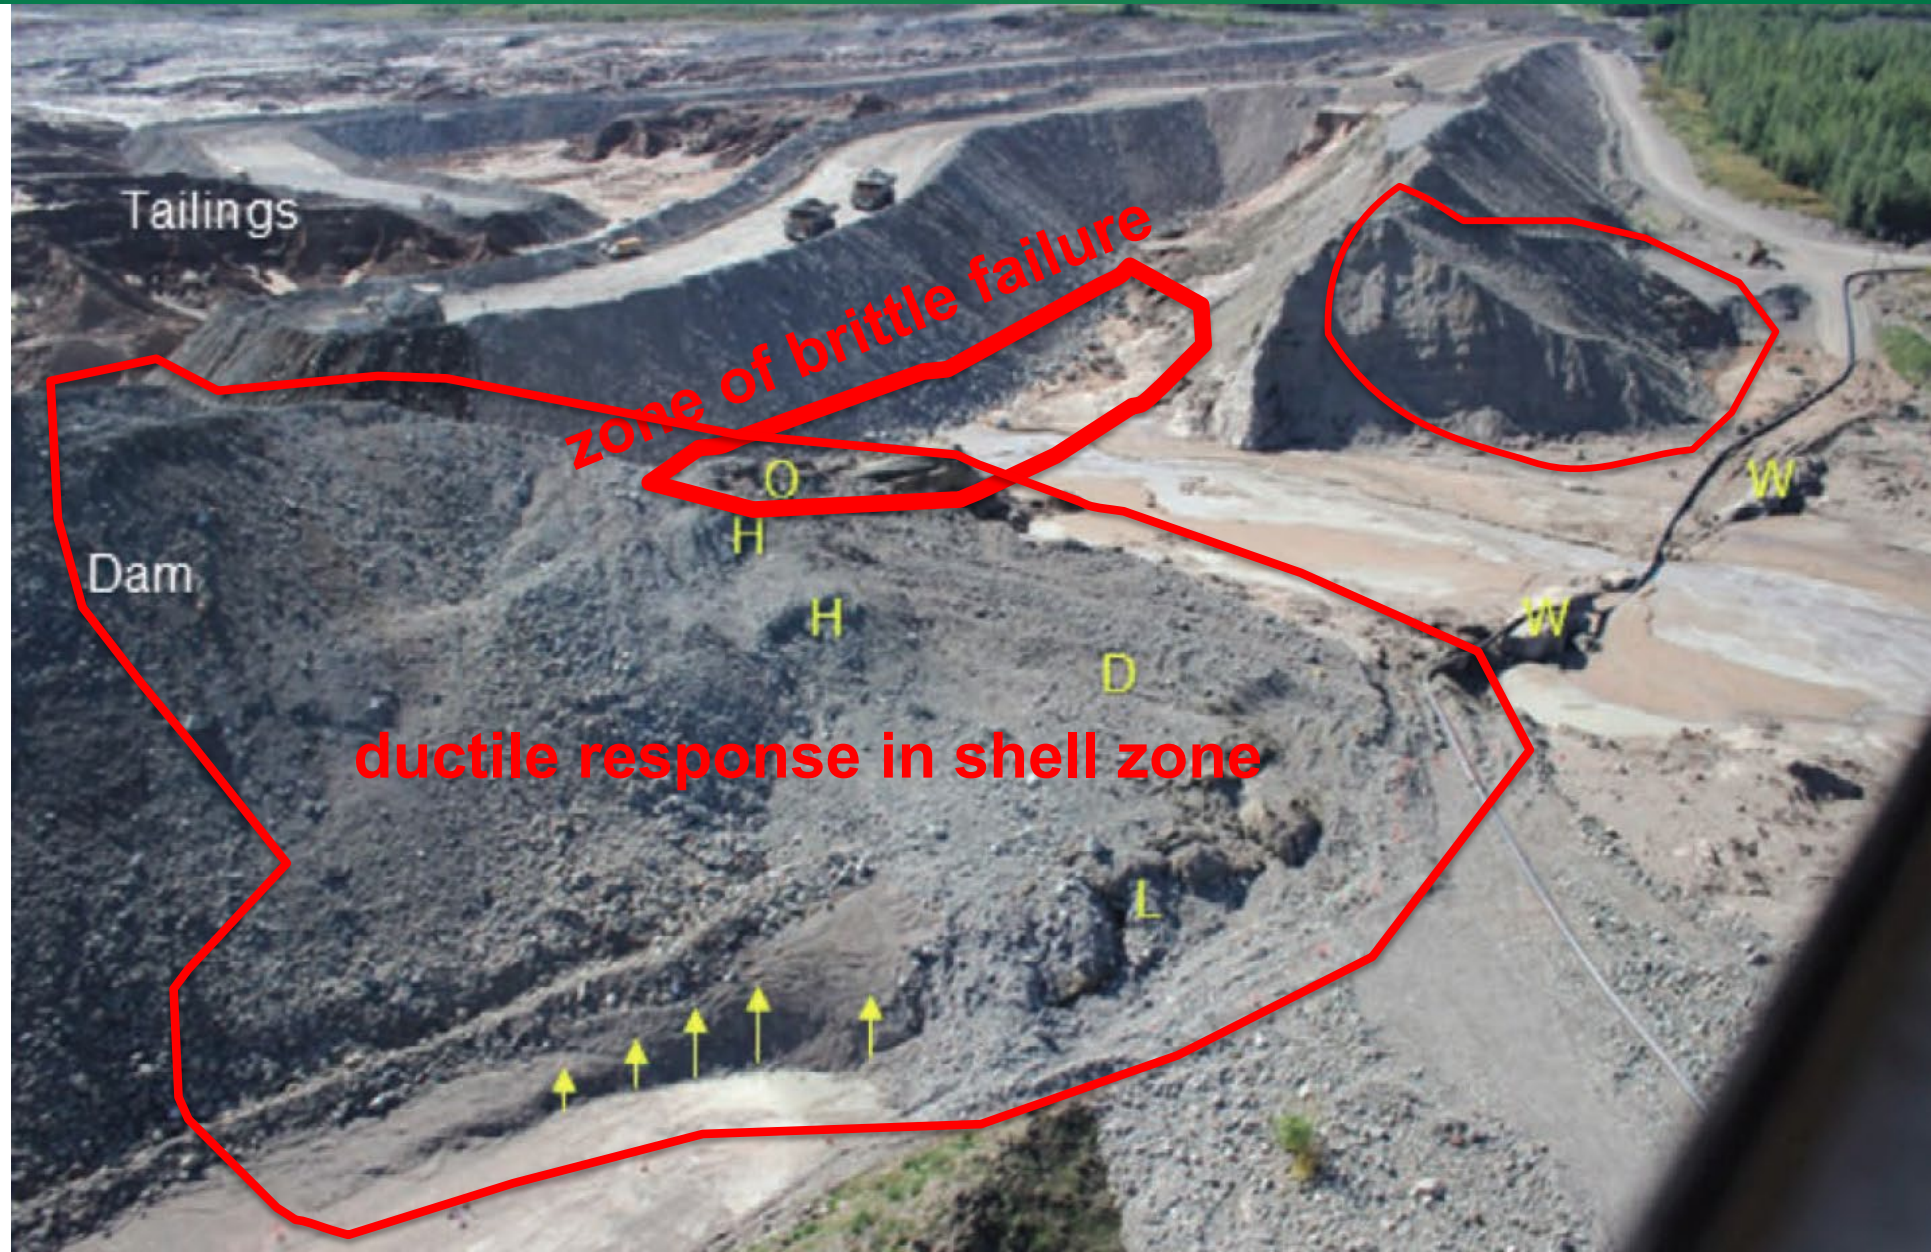
Incremental horizontal displacements during collapse

- $0 < \text{shear band} \leq 12\text{cm}$
- distinctly asynchronous shear strength mobilization

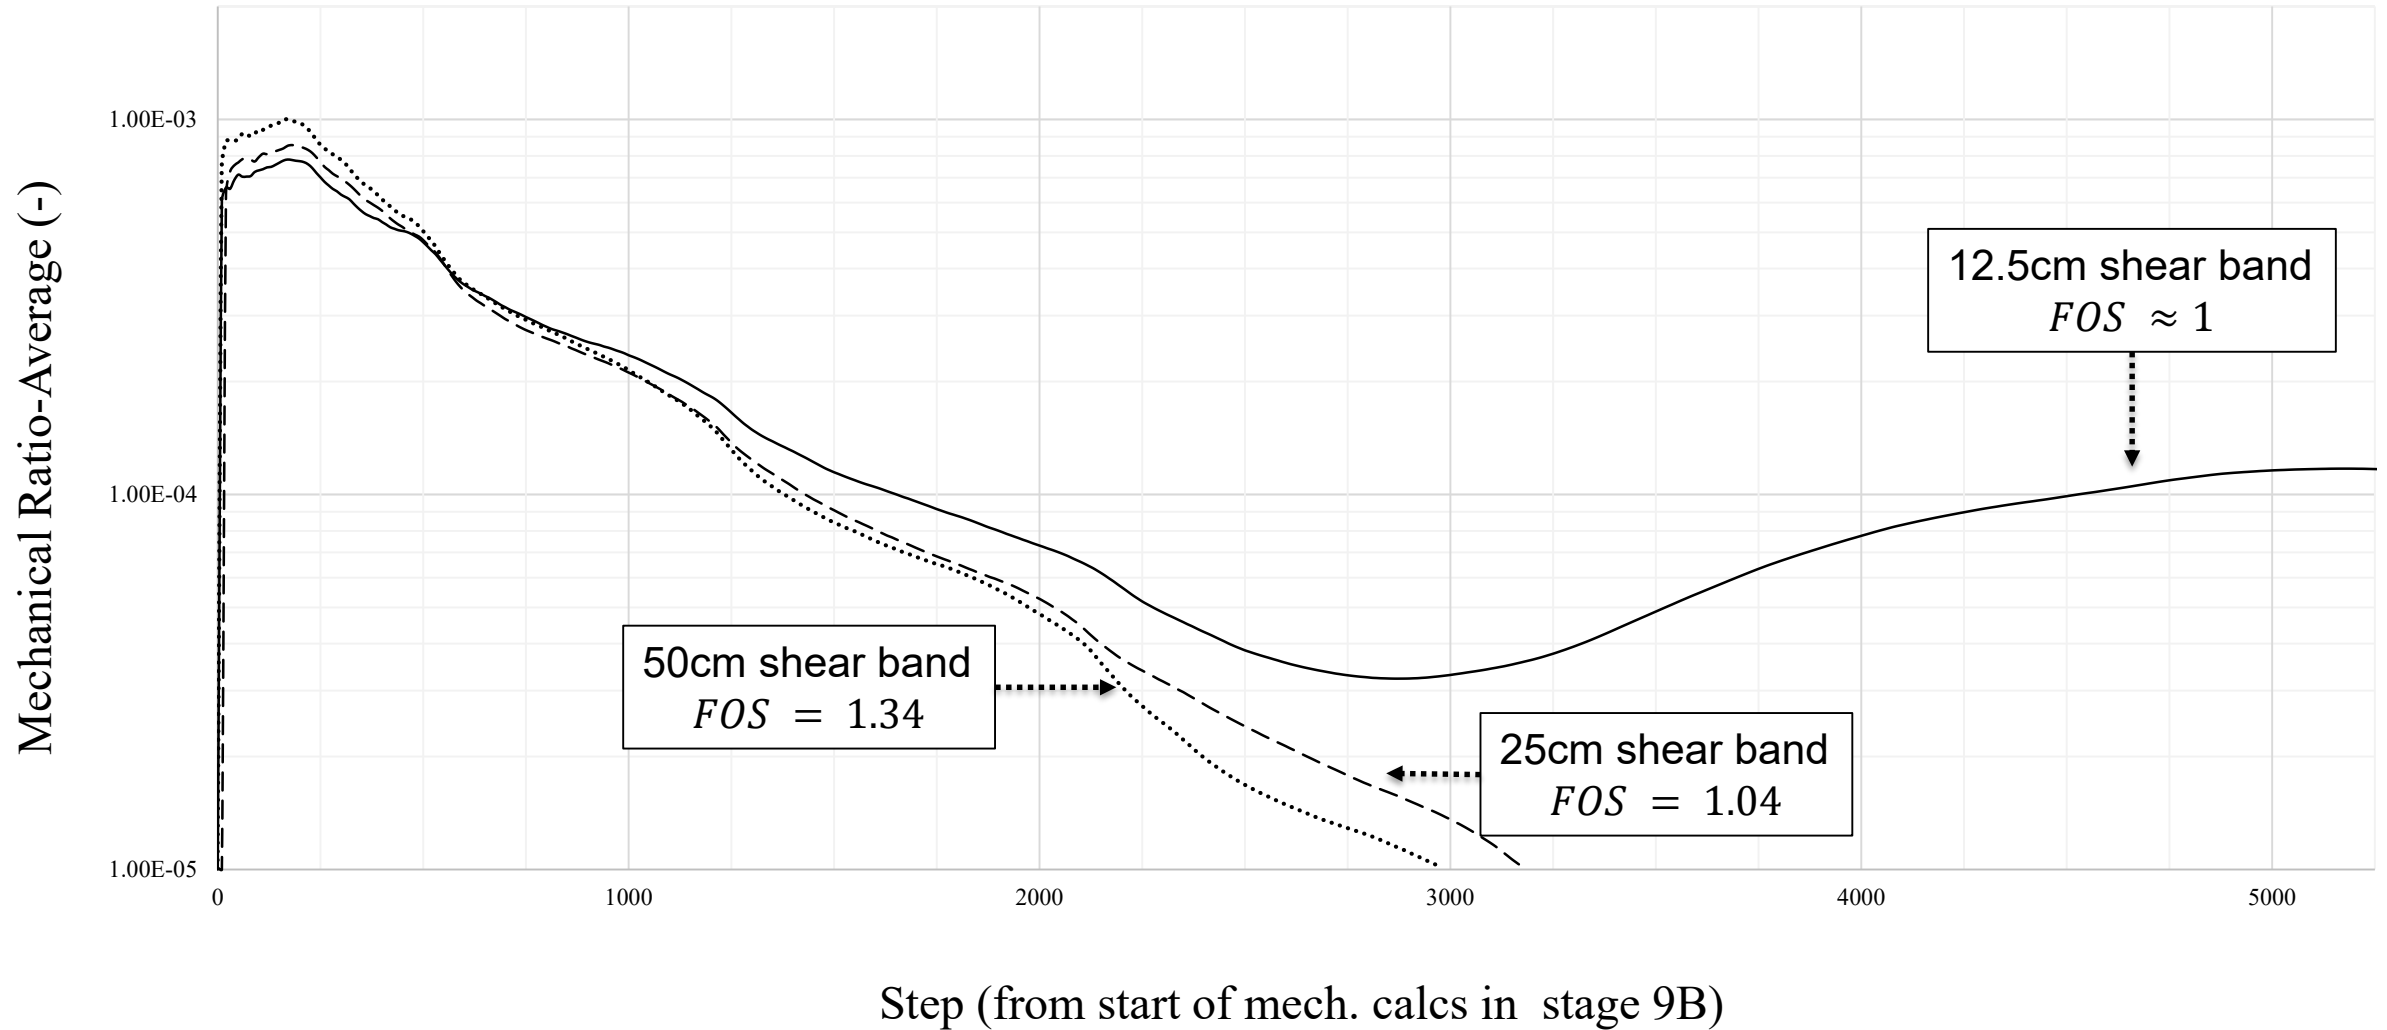
MODEL RESPONSE TO LOADING IN THE FINAL CONSTRUCTION STAGE (9B) using the most conservative interpretation of the strain-weakening curve in the Upper GLU

2014 - END OF COLLAPSE SIMULATION

plastic shear strains (%)

■ ≥ 60 (residual)
■ ≤ 5 (peak)

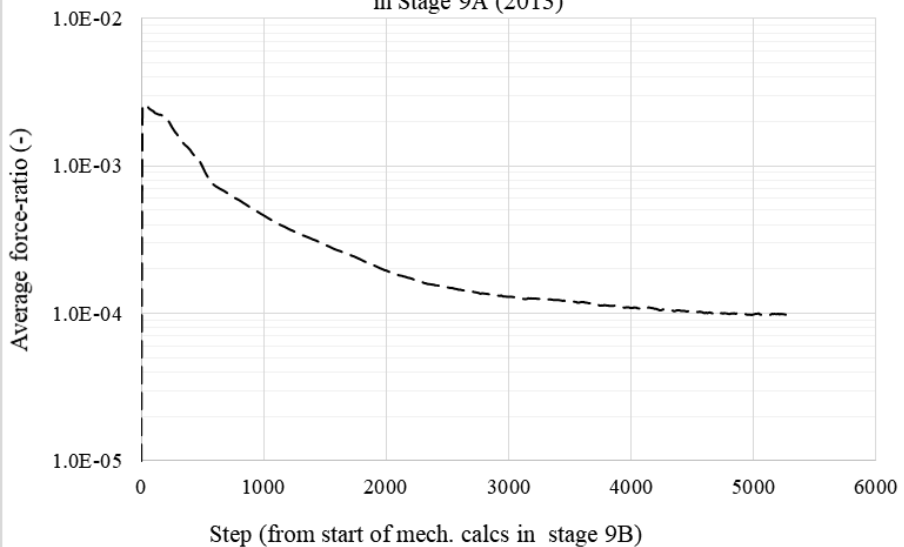
LOWER LIMIT STATE ANALYSIS
Mechanical Ratio-Average vs. Calculation Step
in Stage 9A (2013)

From scale effects: shear band no thicker than 12.5cm

From analysis of lower limit state: : shear band > 0

$0 \text{ cm} < \text{SHEAR BAND} \leq 12.5 \text{ cm}$
