# **3D Stability Analysis of Left and Right Abutment Cut Slopes of a Hydroelectric Project in Himalaya**

**Sripad R Naik, Roshan Nair & Sudhakar Kadiyala**

**National Institute of Rock Mechanics, India**

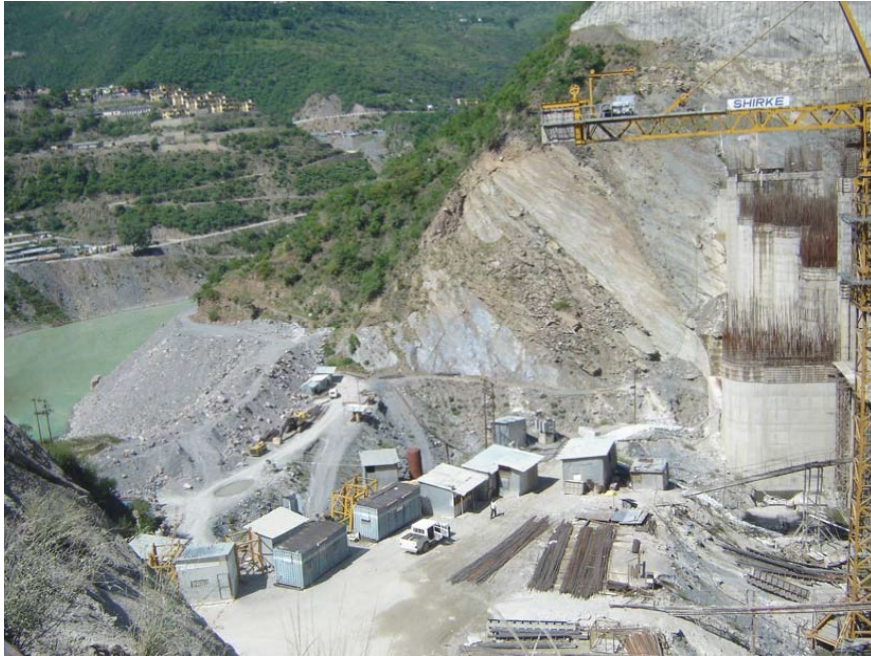
← **Upstream side of left abutment slope**

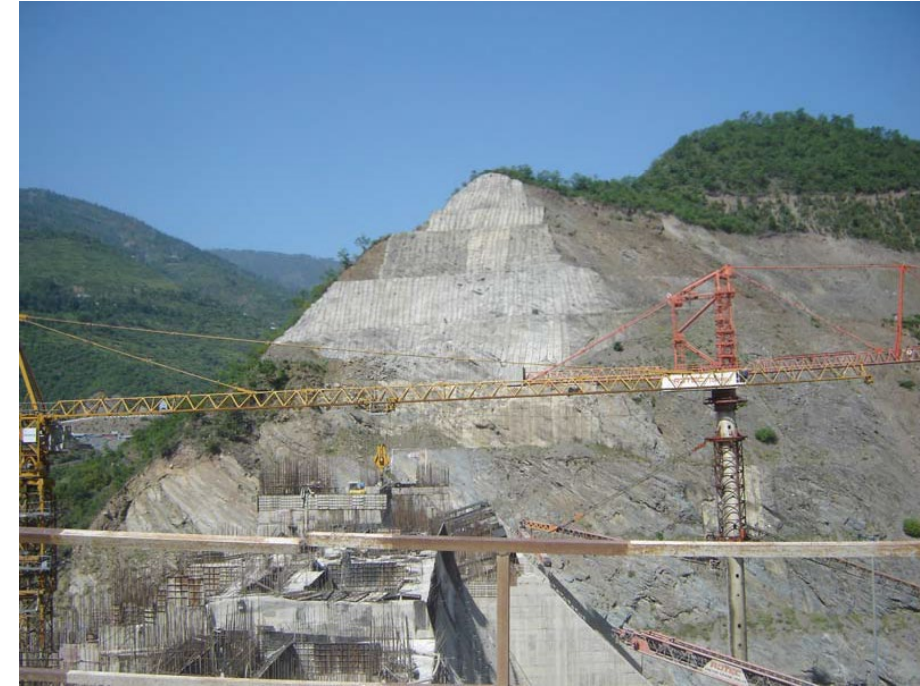
**Left abutment slope near dam axis** →

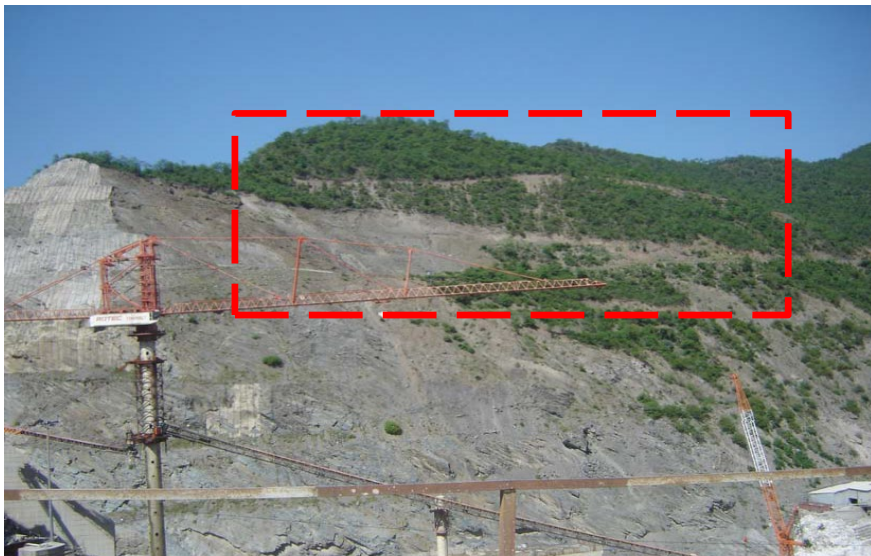
← **Slump mass region in downstream of left abutment slope**

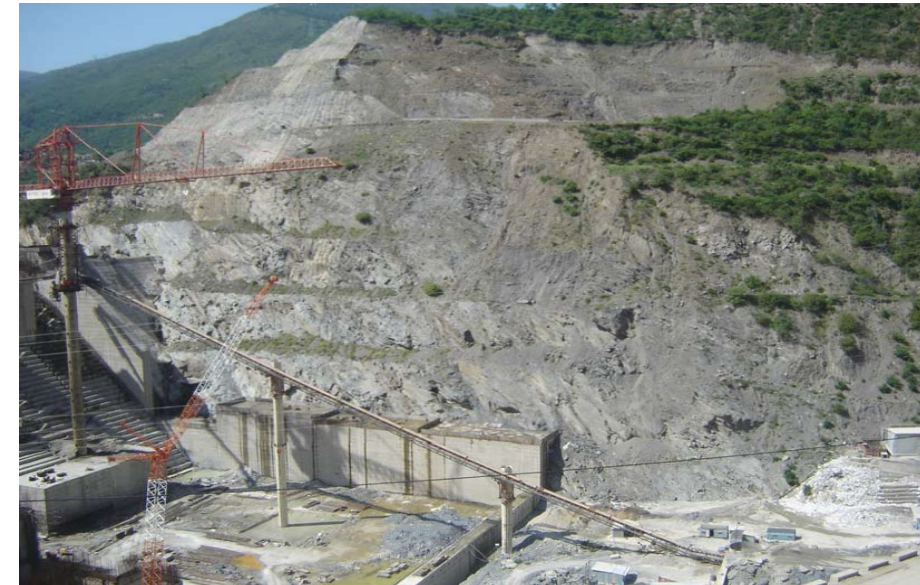
**Concrete wall provided at lower slopes of left abutment till ch:150m from dam axis** →

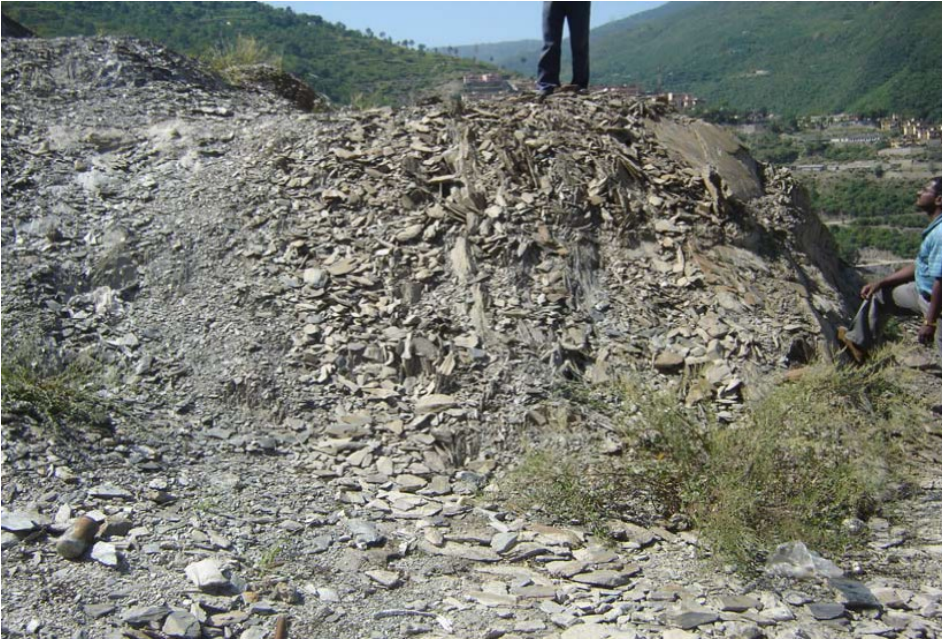
← **Highly  
disintegrated  
thinly bedded  
phyllites on right  
abutment slope**

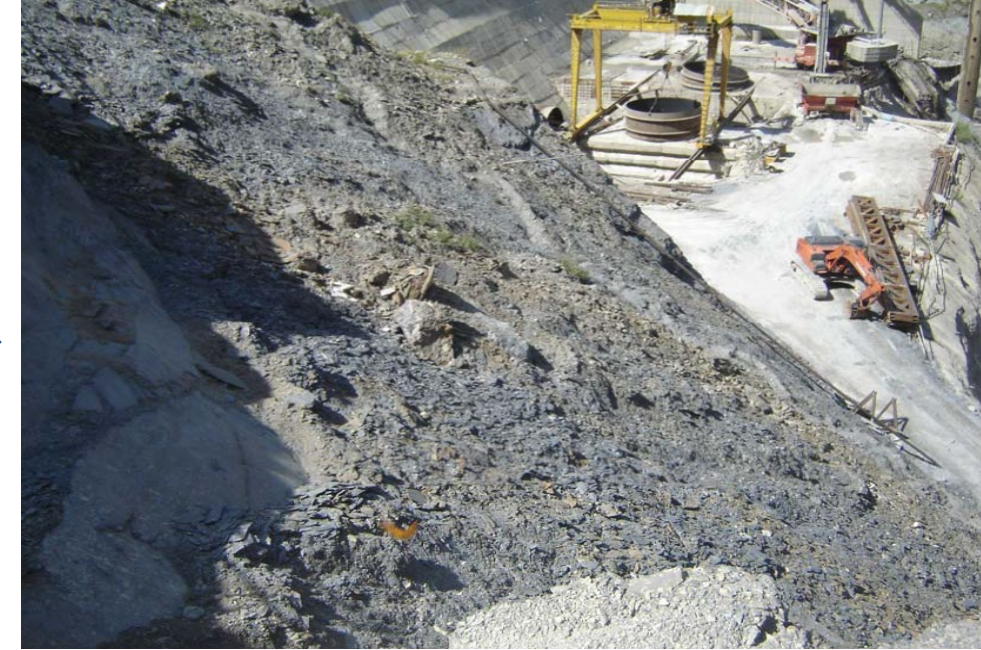
**Sheared  
phyllites  
existing on the  
right abutment  
slope** →

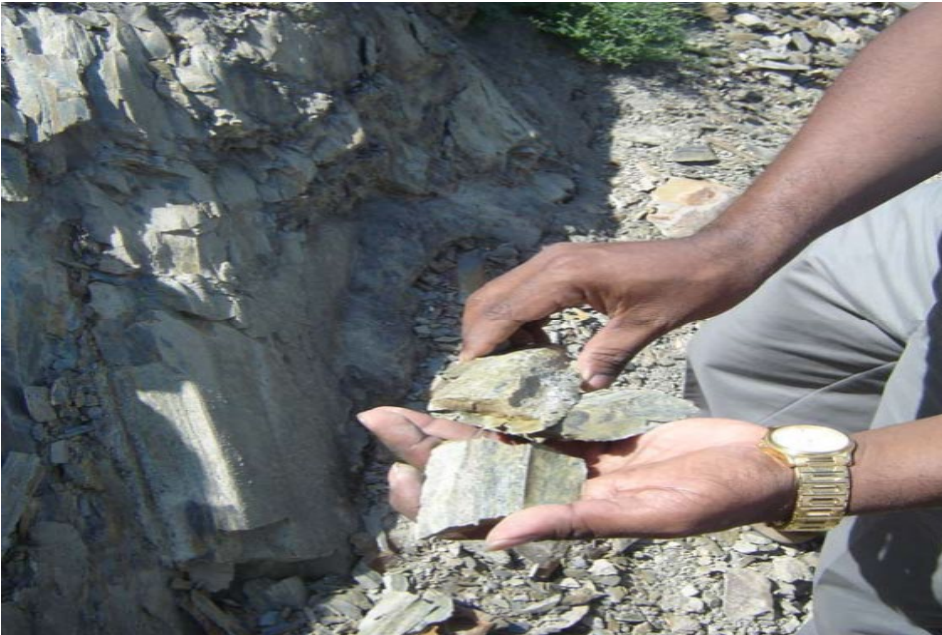
← **Highly  
disintegrated  
thinly bedded  
phyllites**

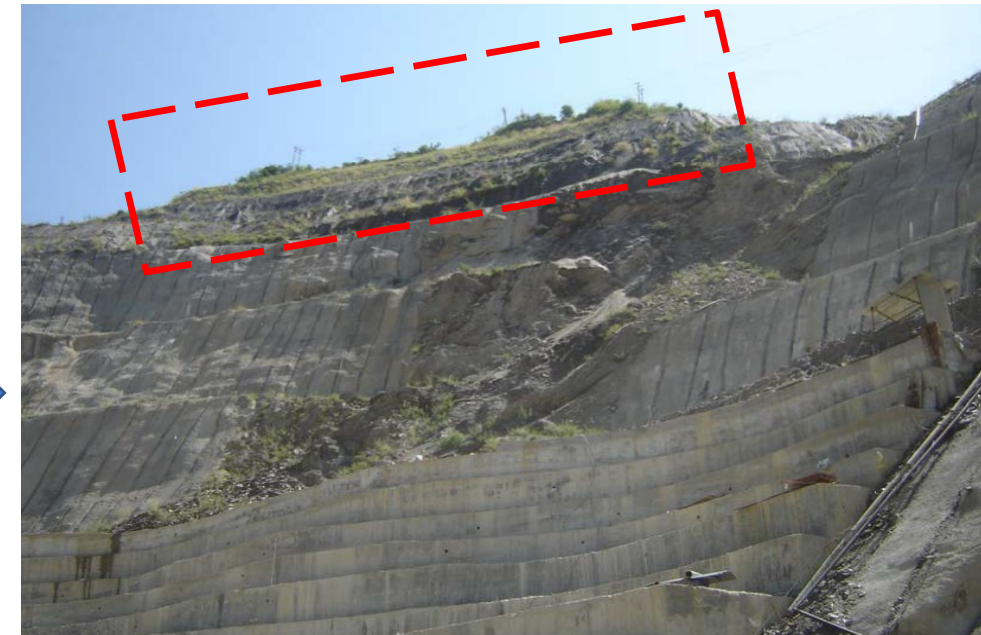
**River bed material  
visible on the upper  
slopes of right  
abutment** →

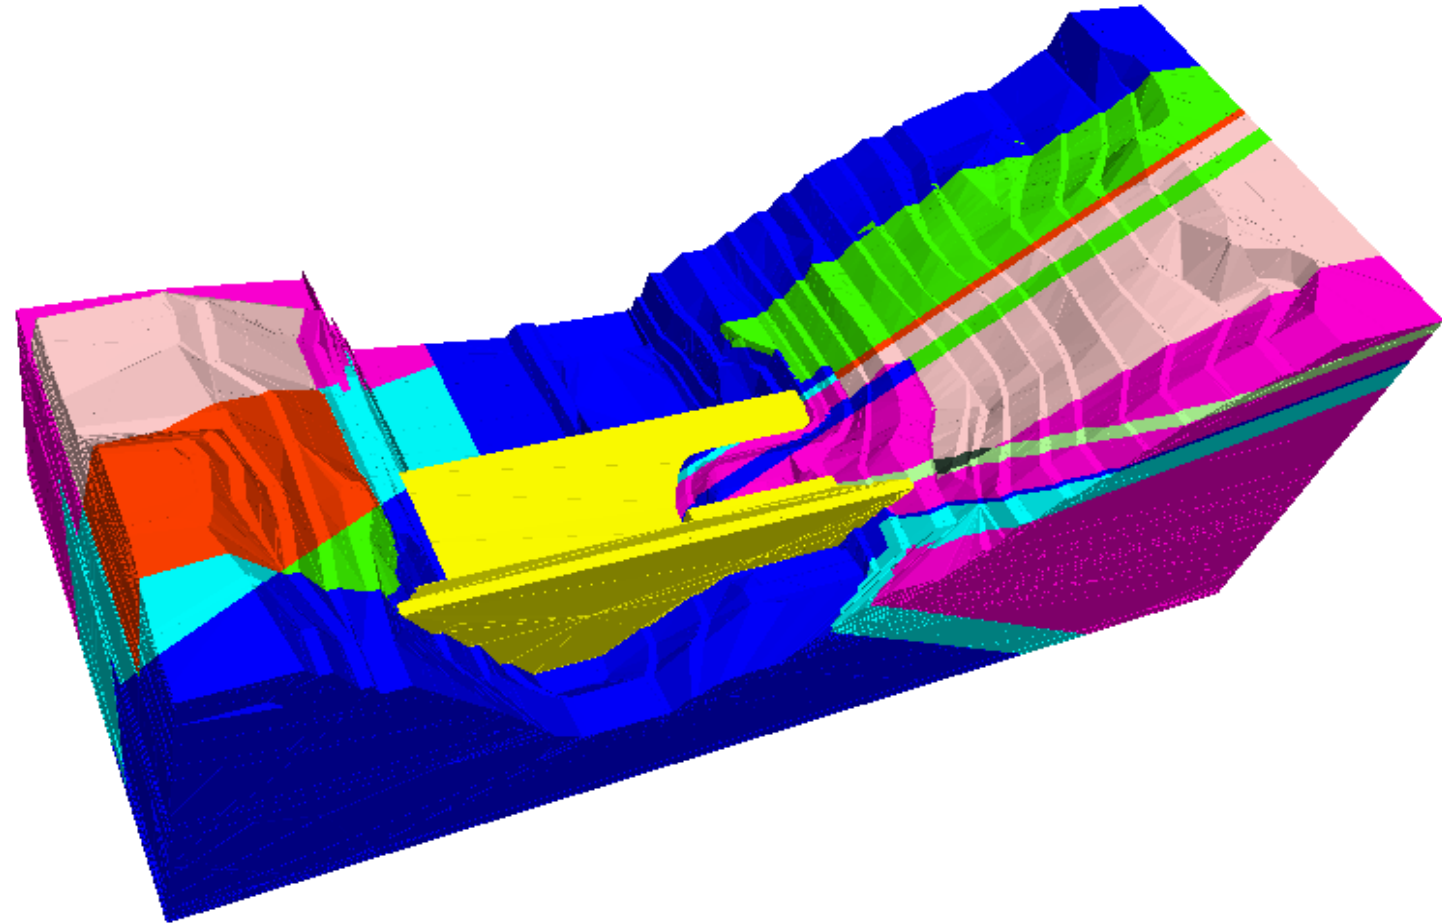
- Massive Phyllite
- Massive Phyllite (W)
- Thinly bedded phyllite
- Puckered limonitised phyllite (W)
- Puckered limonitised phyllite
- Sheared Phyllite
- Thinly bedded phyllite (W)
- Dam
- Sheared Phyllite (W)

# Translation of Site Geology into a 3D Discontinuum Model

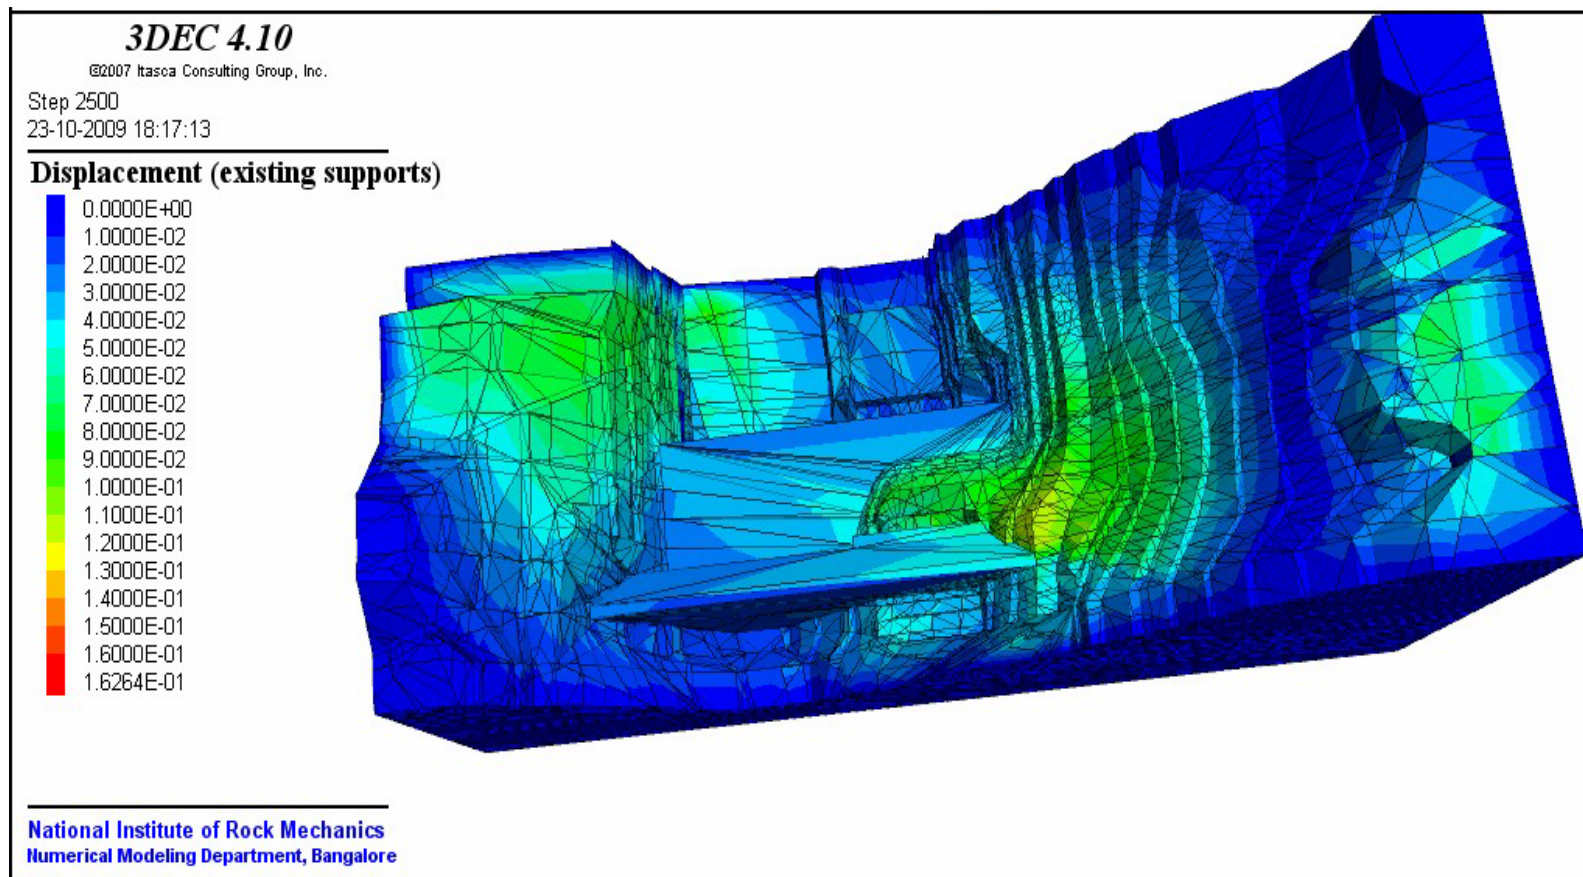
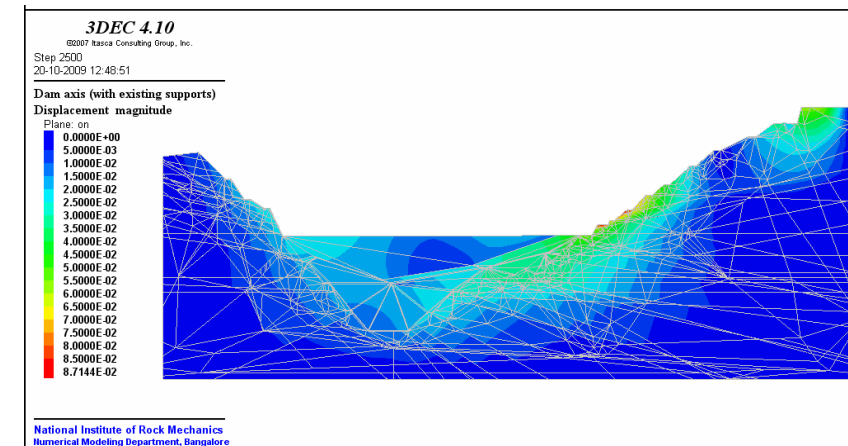
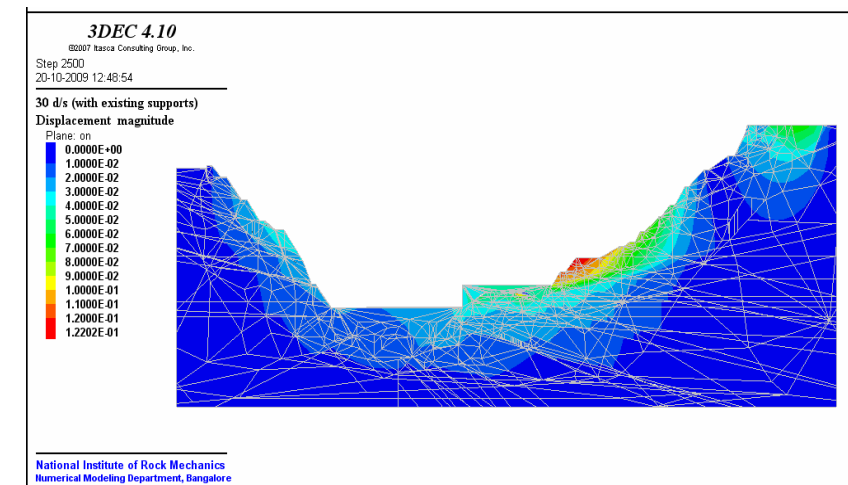
# Model -1 Results

- Maximum displacement was found to be 162.64 mm.
- The model showed significant displacement at upper elevation of left abutment slopes beyond 150 m chainage in downstream side.
- Similarly, the right abutment slopes from dam axis to 150 m chainage and EL of 570 m to 640 m experienced significant displacement

- **The first model with the existing support system showed maximum displacement of 162.64mm. The model shows significant displacement at upper elevation of left abutment slopes beyond 150m chainage in downstream side.**
- **Similarly, the right abutment slopes from dam axis to 150m chainage and EL of 570m to 640m experienced significant movement. The maximum movement was observed in the area of sheared phyllite contact with the limonotised puckered phyllites.**
- **It was observed that due to the orientation and angle of the slopes, the vertical component of the displacements are higher than the horizontal component.**

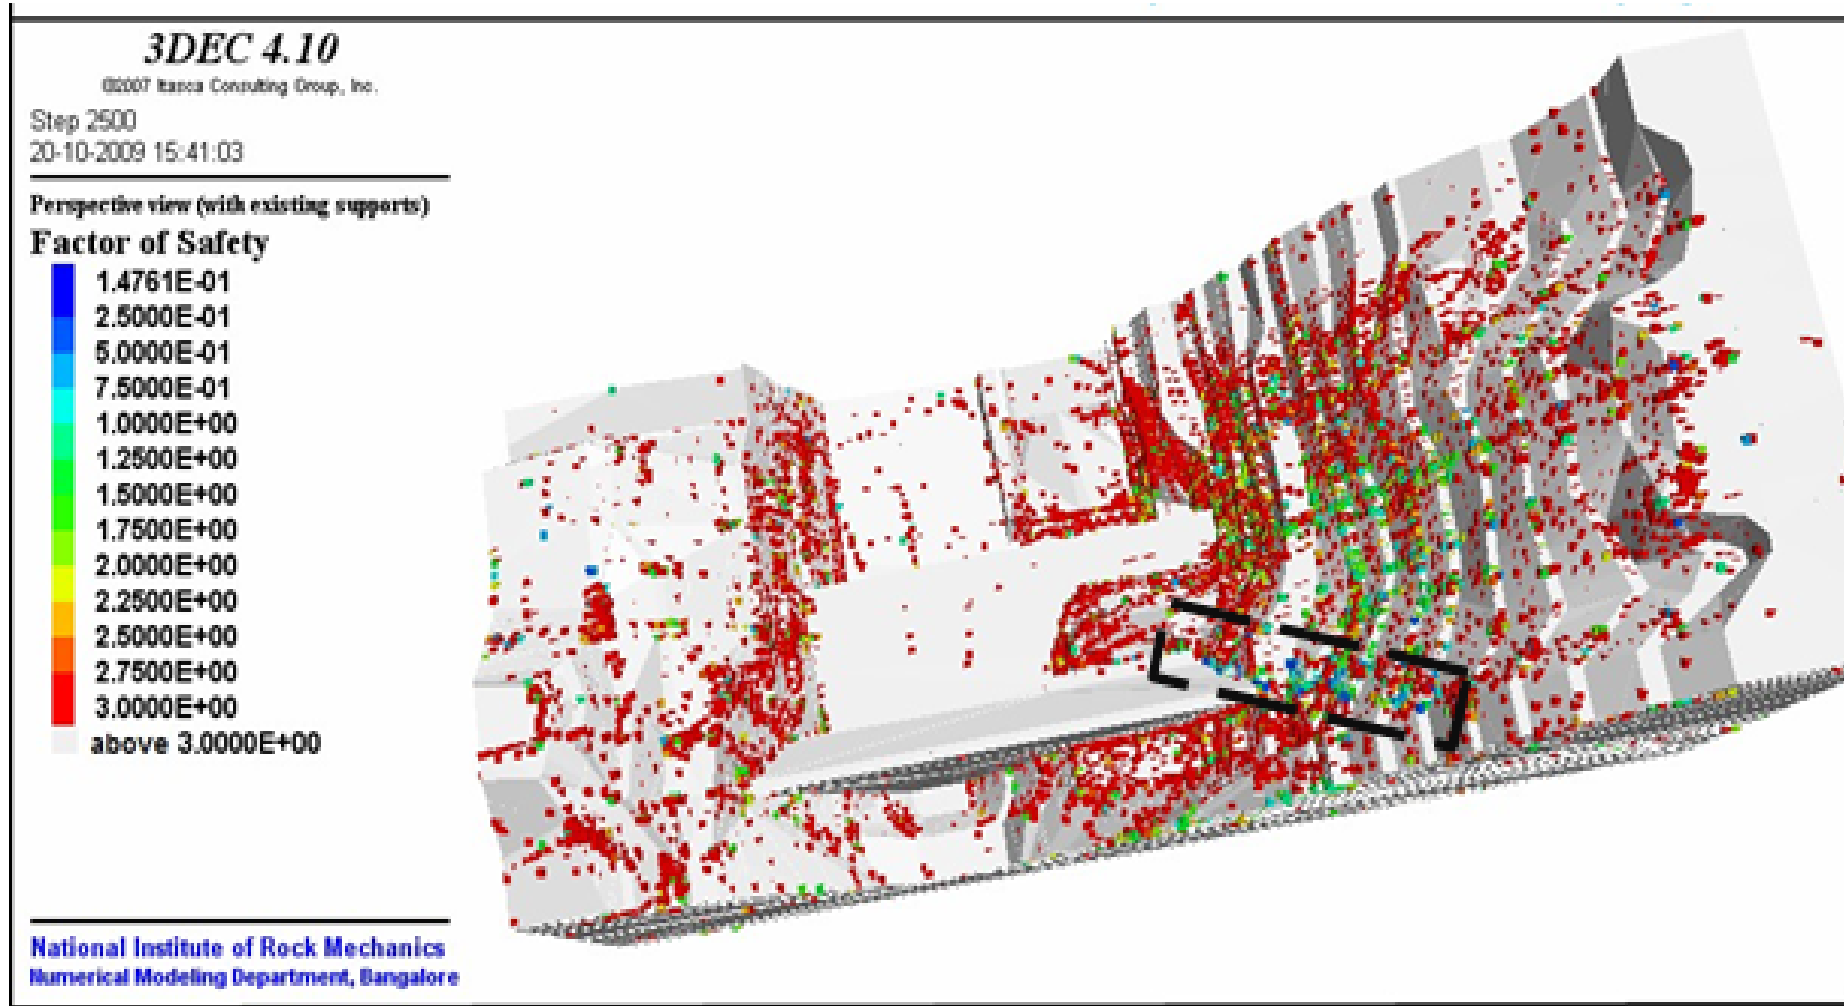
**It can be seen that most of the location on the slopes have factor of safety higher than 1.5. However, on right abutment slope, factor of safety was found below 1.5 in the areas where sheared phyllites are exposed.**

- **The factor of safety at most of the location on the slopes was more than 1.5. However, on right abutment slope, factor of safety was found below 1.5 in the areas where sheared phyllites are exposed.**
- **The model studies clearly shows that cable anchors with no pretension are more suited for the present geological set up**

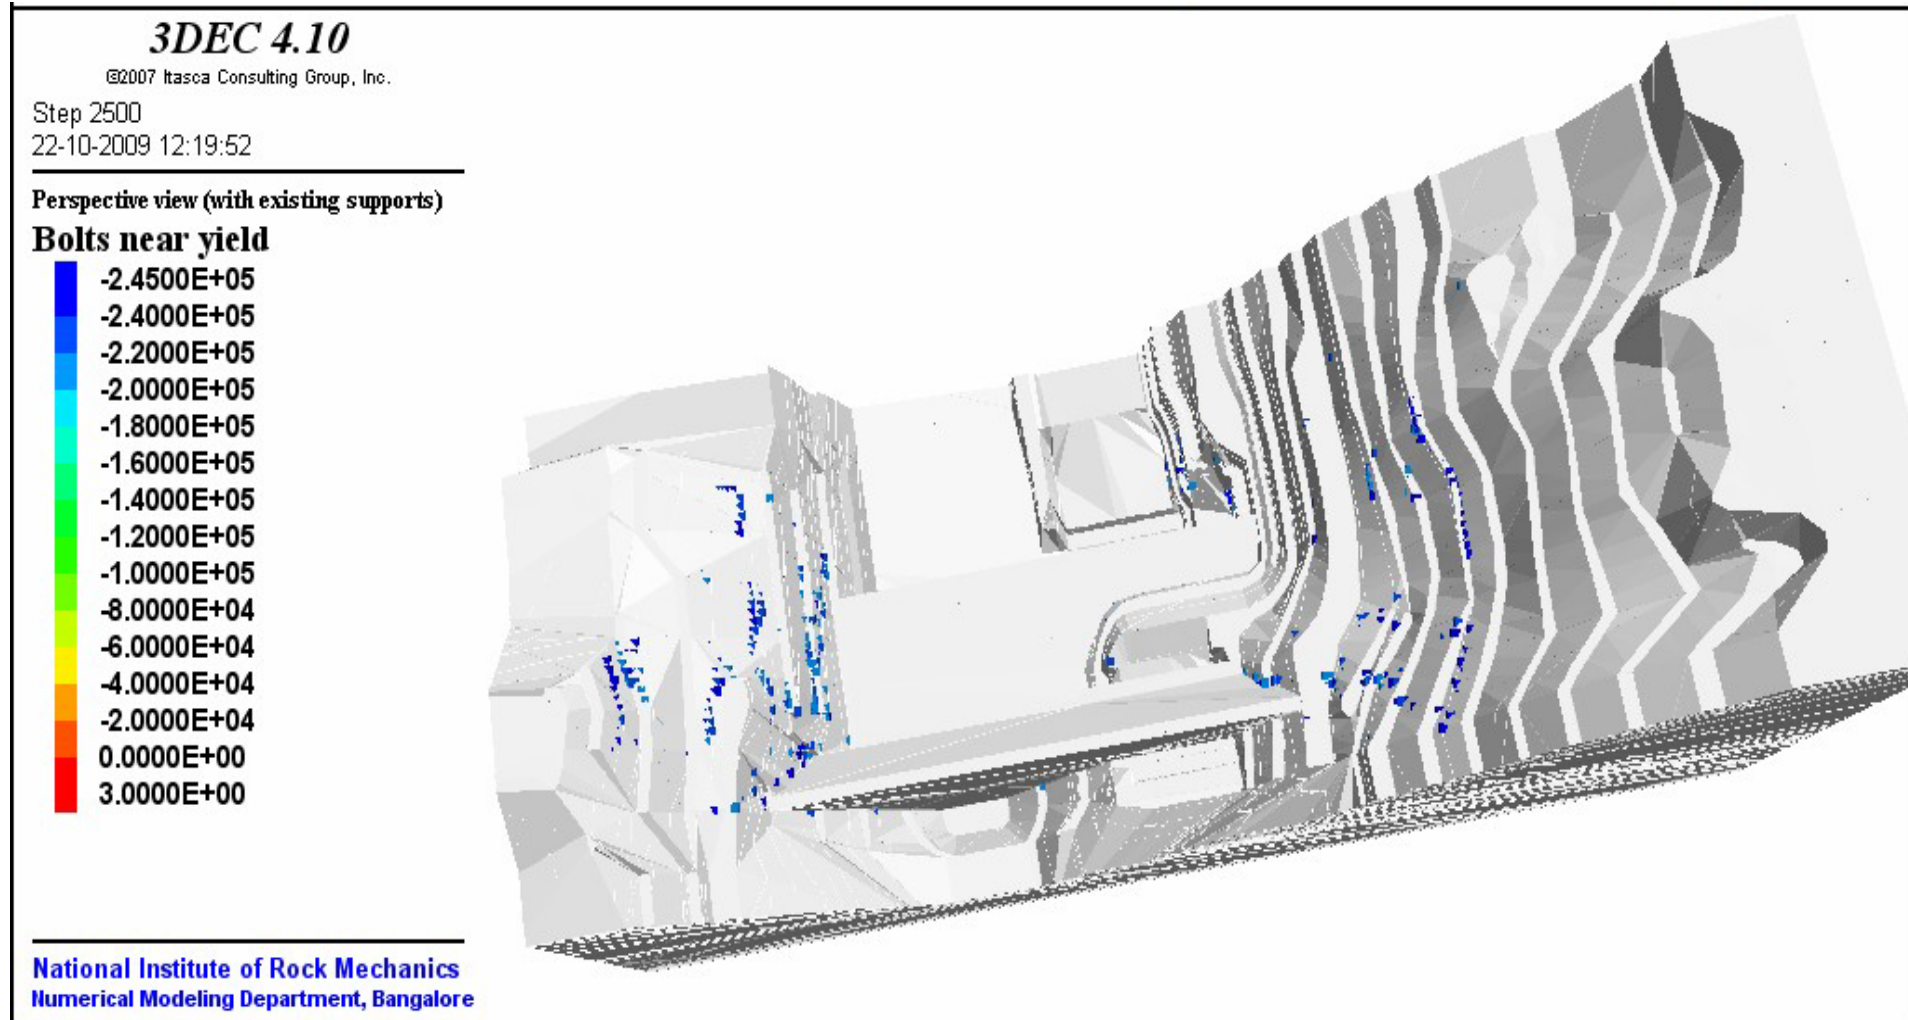
**The results also revealed that nearly 961 rock bolts were on the verge of yielding.**

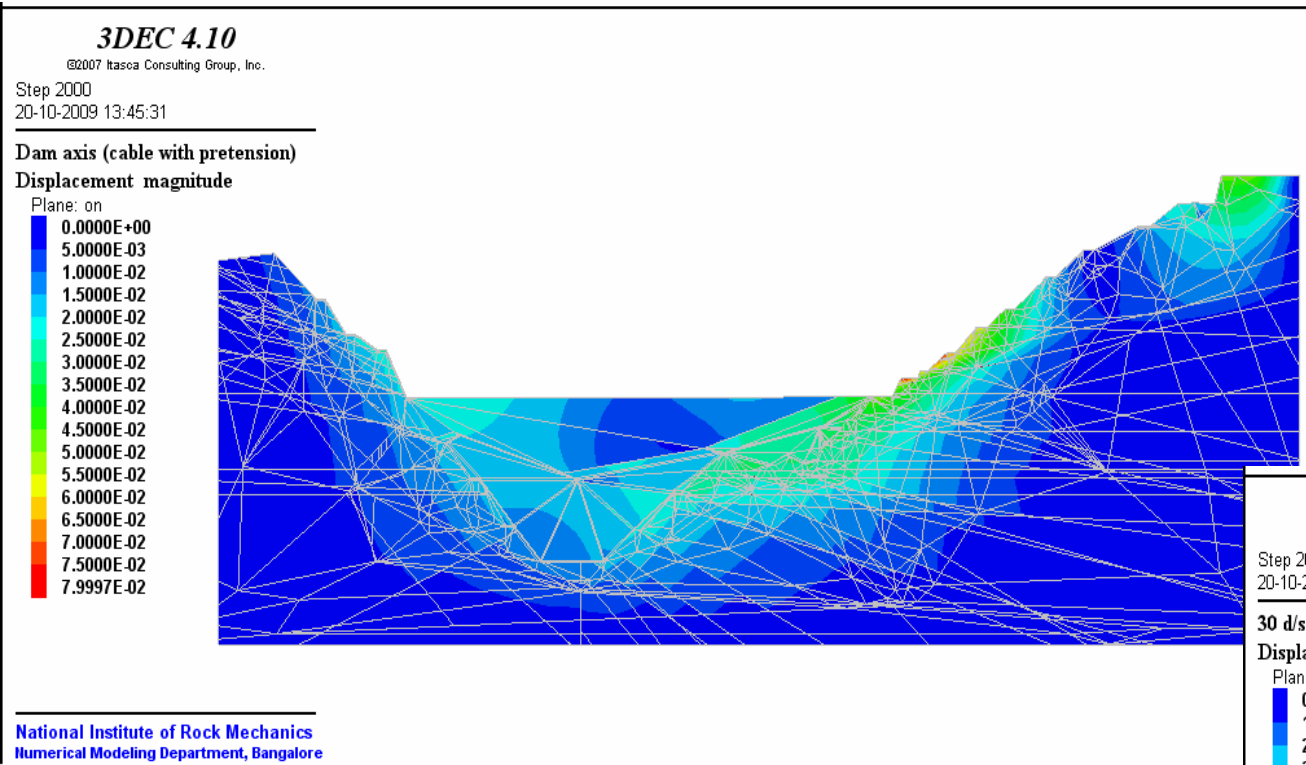
## On Right abutment slopes :

(Cable spacing 10m x 10m)

- Cable anchors from EL 590m to 630m at 30m d/s to 130m d/s
- Cable anchors from EL 605m to 630m at dam axis to 20m d/s
- Cable anchors from EL 628m to 660m at 10m u/s to 20m u/s

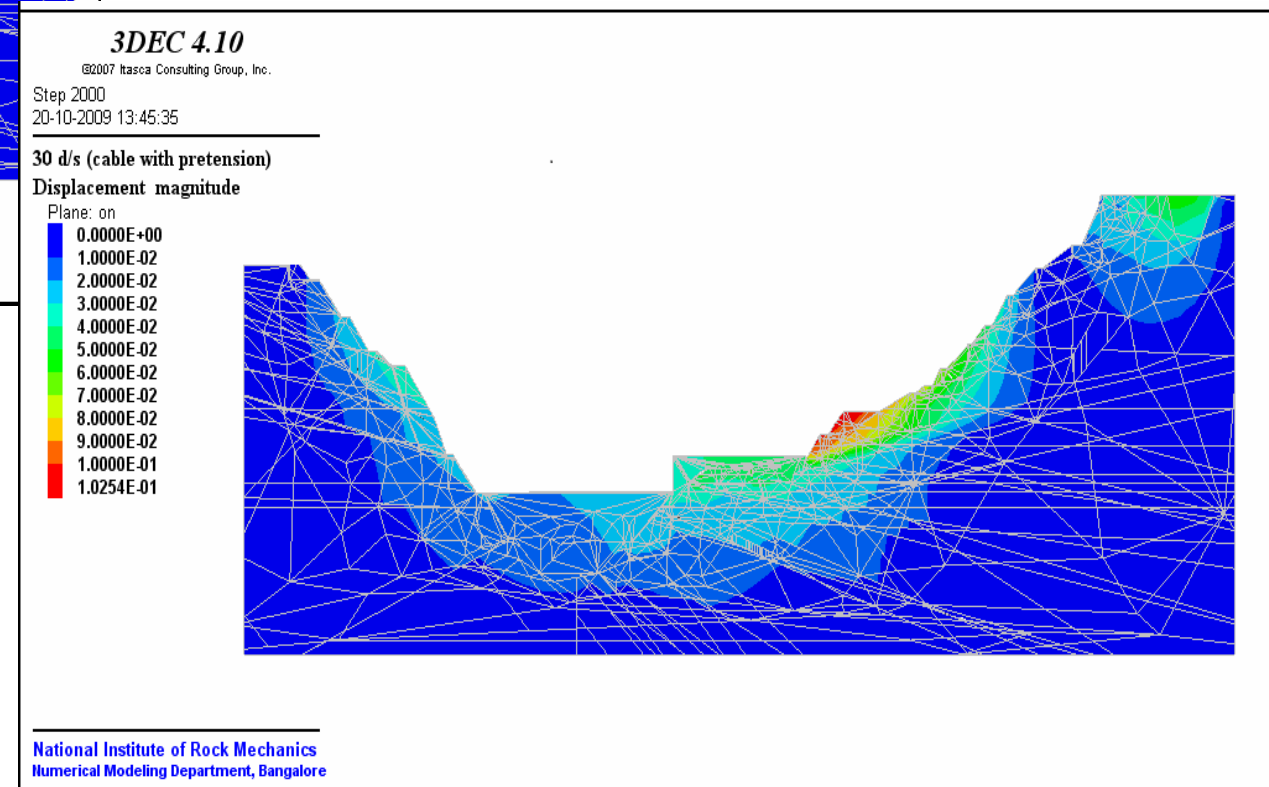
**Maximum Displacement at 30 d/s came down to 102.55 mm from 122mm with Pre-tensioned cable anchors**

**Maximum Displacement at Dam Axis came down to 79.99 mm from 87.14mm with Pre-tensioned cable anchors**

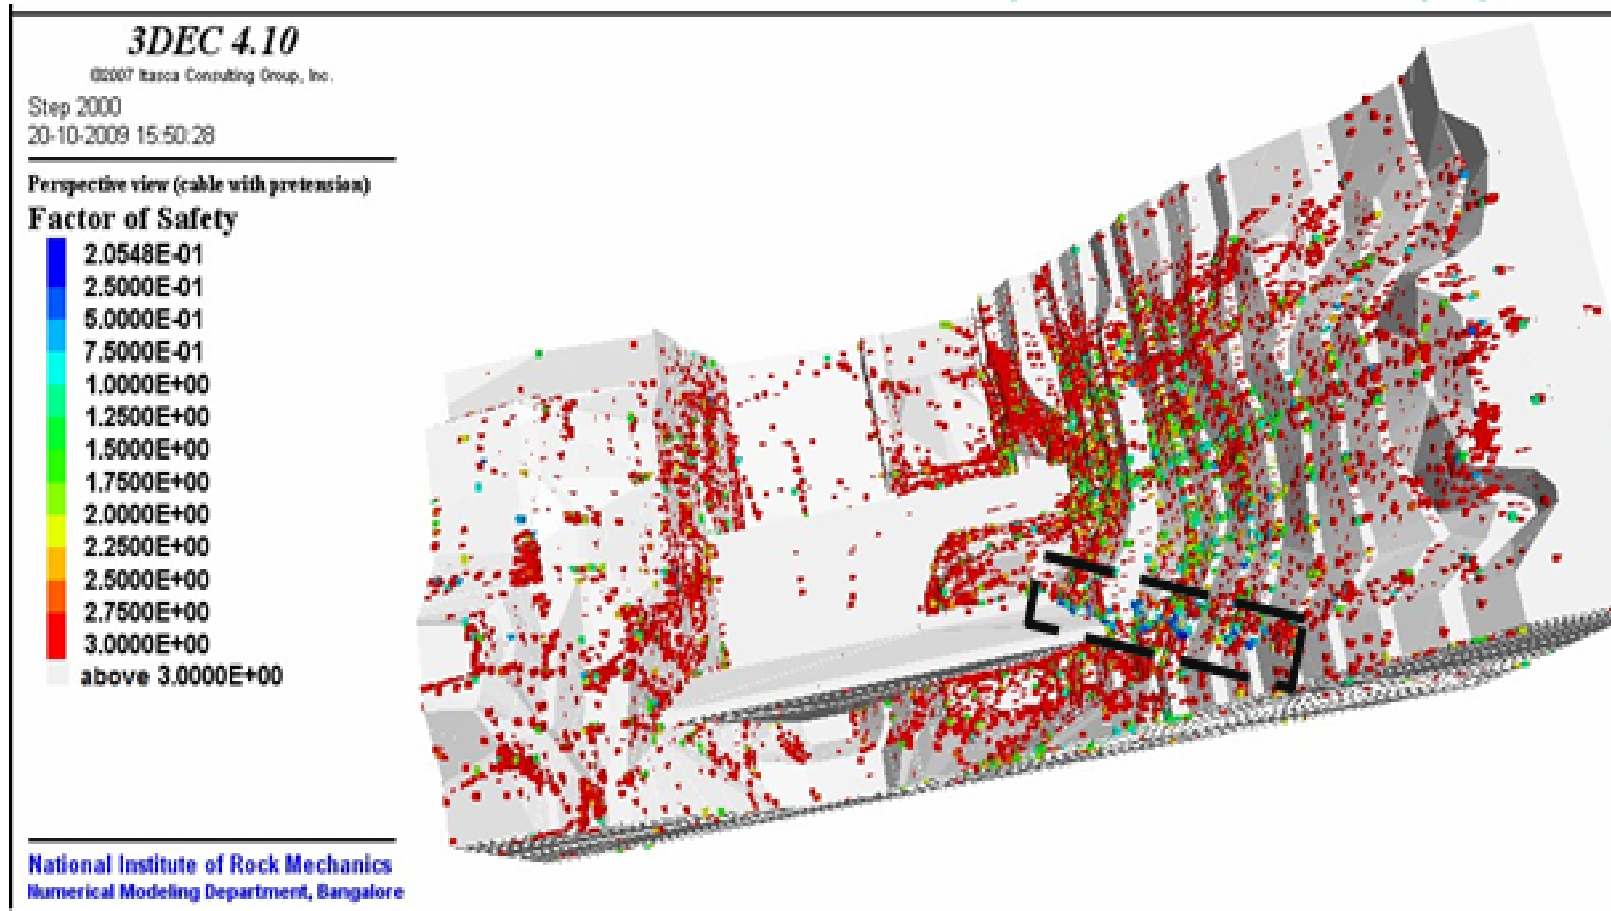
The number of bolts near yield was found to be 961. The results also revealed that nearly 77 pretensioned cable anchors were on the verge of yielding

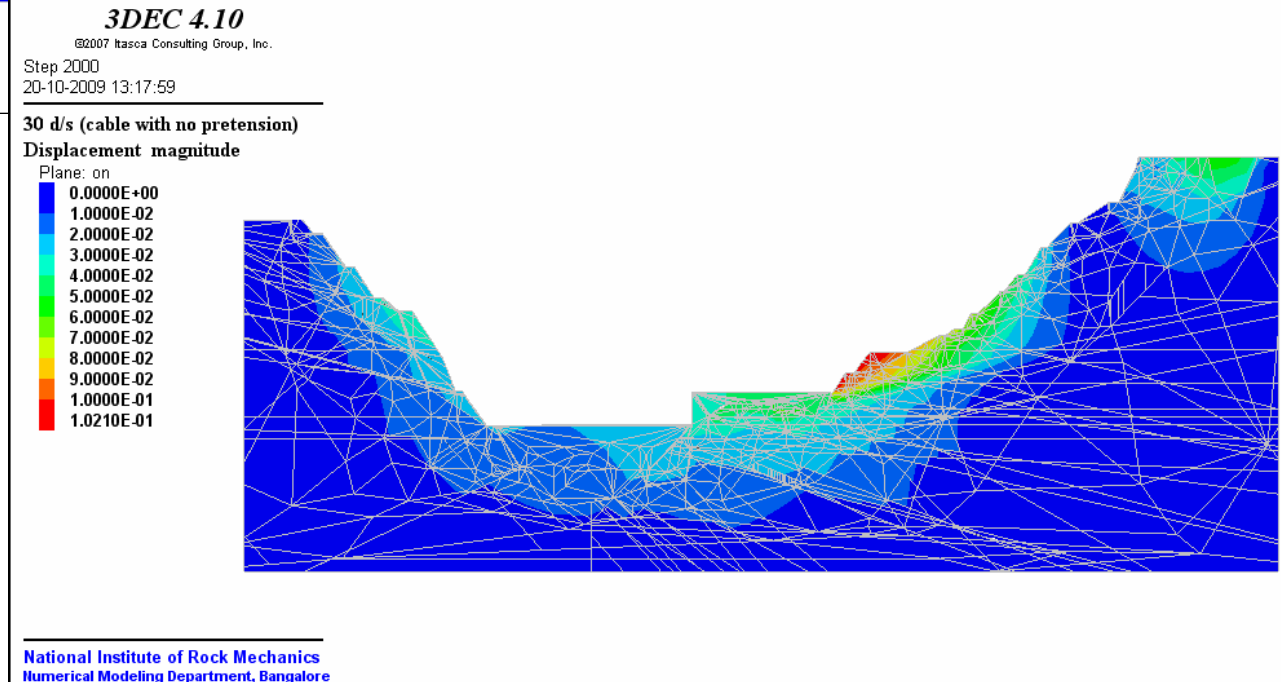
**No Appreciable Changes in Displacement compared to case with Cables –Pretensioned**

**The overall factor of safety of slopes, when cable anchors were not pretensioned, reduced by nearly 20% in comparison with slopes stabilized with pretensioned cable bolts.**

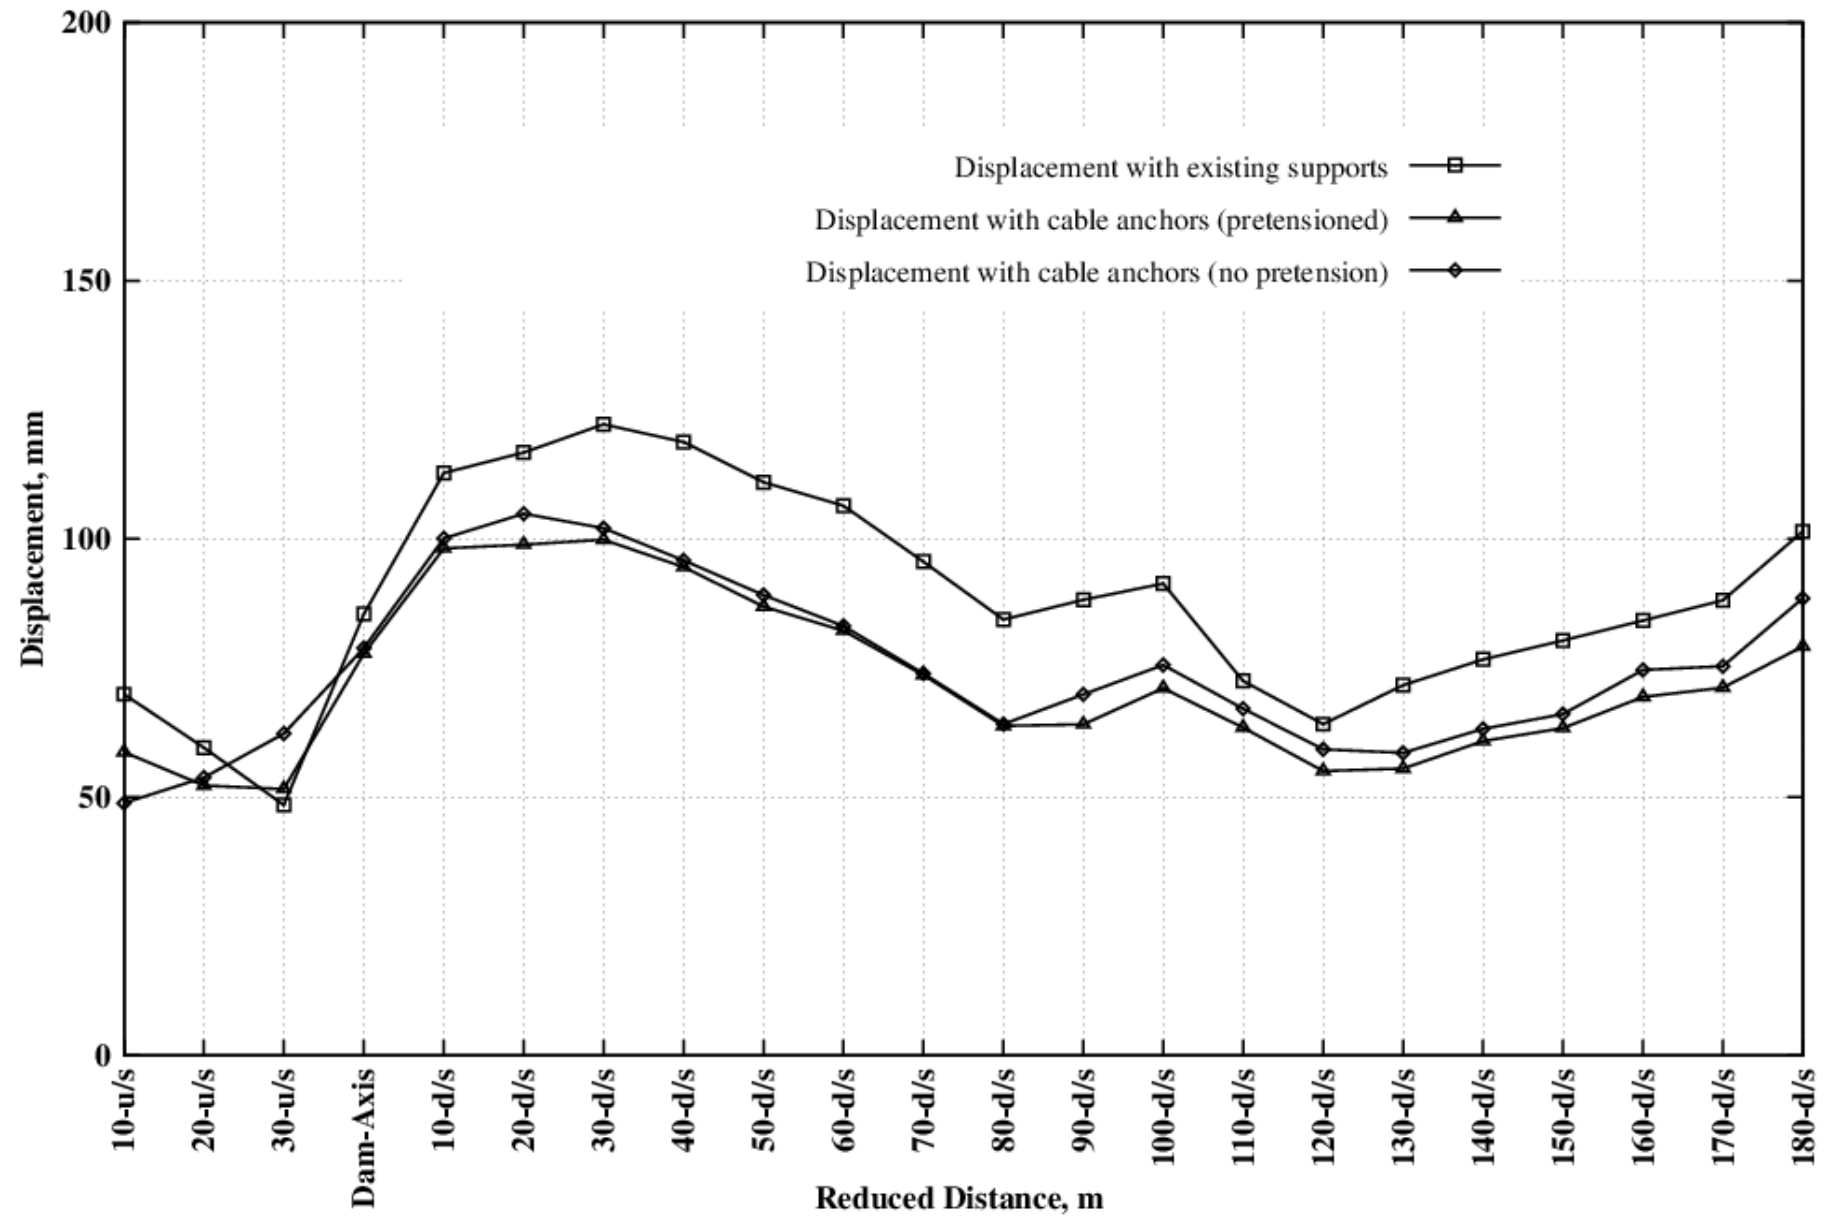
## Comparison of displacements obtained during analysis
