PROJECT DESCRIPTION

Built between 1959 and 1961, Junction Dam is a double-curvature concrete arch dam located on Silver Creek in El Dorado County, California, just downstream from where Little Silver Creek and South Fork Silver Creek merge. The dam is in a relatively narrow canyon with steep sides and retains the Junction Reservoir. The dam is 168 ft high with a crest length of 525 ft. It has a reservoir capacity exceeding of 2,600 ac-ft (at an elevation of 4,450 ft). It is part of the Upper American River Project (UARP), which is owned and operated by the Sacramento Municipal Utility District.

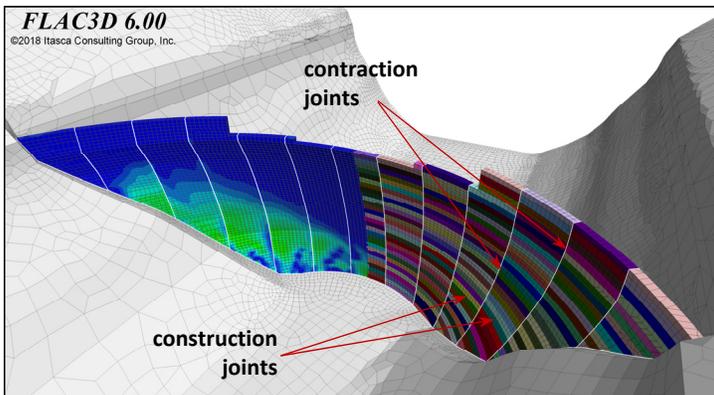
Dam looking downstream showing dynamic stresses with compression blue (left) and model geometry (right).

Particular attention was devoted to the structural joints of the dam with the vertical contraction joints modeled explicitly using interfaces. This approach permitted the evaluation of dislocation and separation. A Ubiquitous Joint constitutive model was adopted for the dam in order to consider the effect of the horizontal construction joints to capture the potential of zero tensile strength.

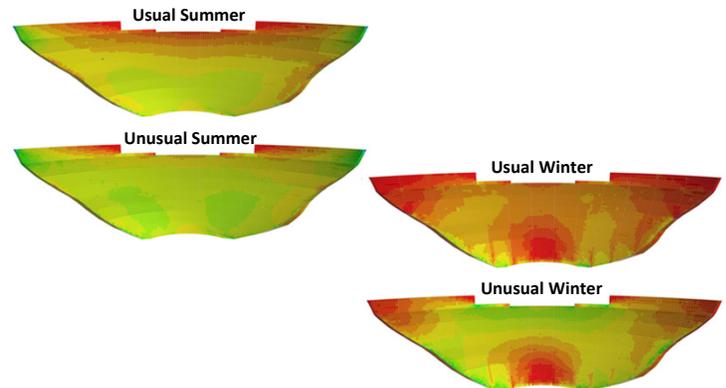
Stresses on the downstream side of the dam for several conditions.

Junction Dam was predicted to perform very well during usual, unusual, and extreme conditions. Maximum compressive stresses during static and dynamic conditions were well below the allowable compressive stresses, and while the dam may be subjected to some temperature-induced shrinkage and limited tensile stresses during winter, it remains stable even under the highest reservoir elevation. Seismically induced deformations of the order of 10 mm. Tensile stresses were predicted to be generally low with only very locally areas with higher tension.
